EPA Quarterly Monitoring Report 1st April 2018 to 30th June 2018

Southern Quarries

15th July 2018

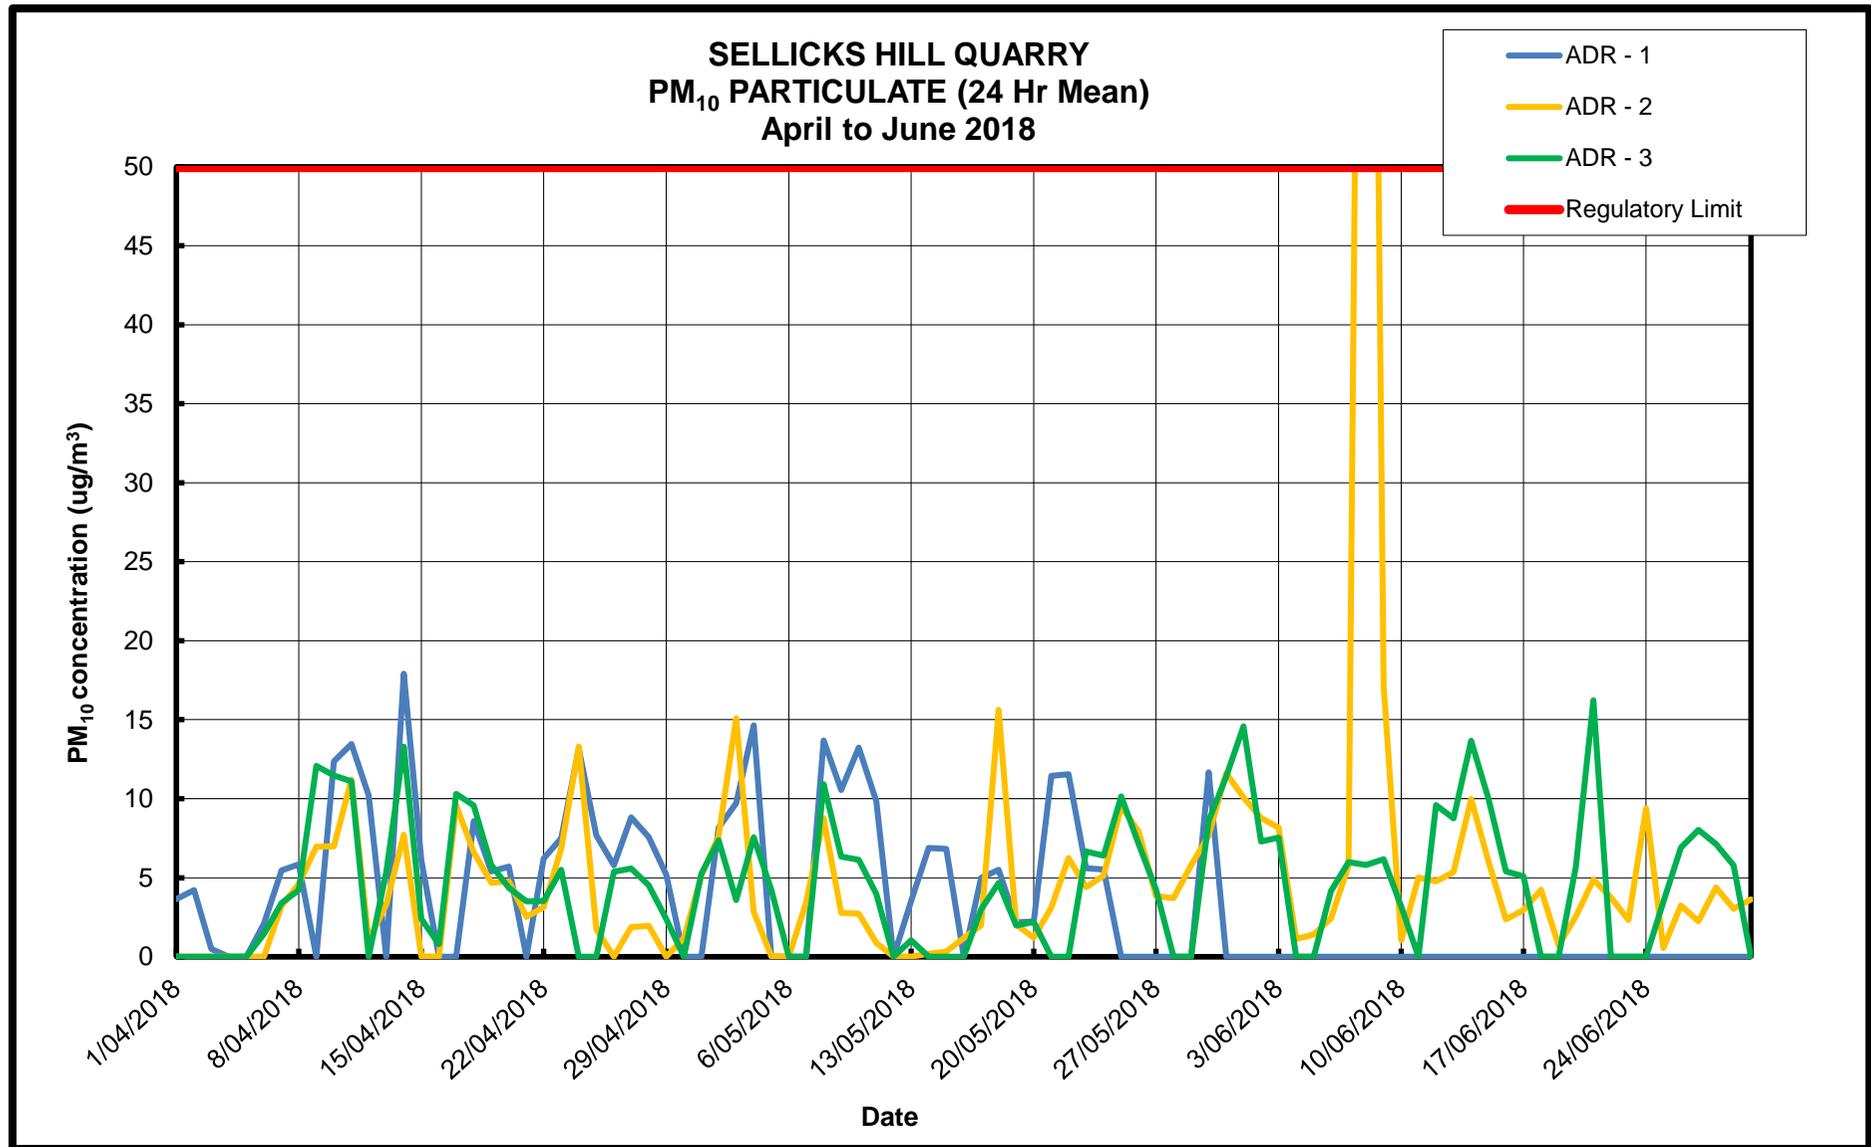
Appendix A – 24 hr Daily Average PM₁₀

ADR unit data showing the 24hr daily mean for the reporting period is attached (see Appendix A – 24hr Daily Average PM_{10}). There was one recorded 24-hour average exceedance ($> 50 \mu\text{g}/\text{m}^3$) at ADR2, but this can be contributed to precipitation and low lying cloud.
