EPA Quarterly Monitoring Report 1st July 2018 to 30th September 2018

Southern Quarries

This document comprises the Quarterly Dust Monitoring Report for the period 1st July 2018 to 30th September 2018.

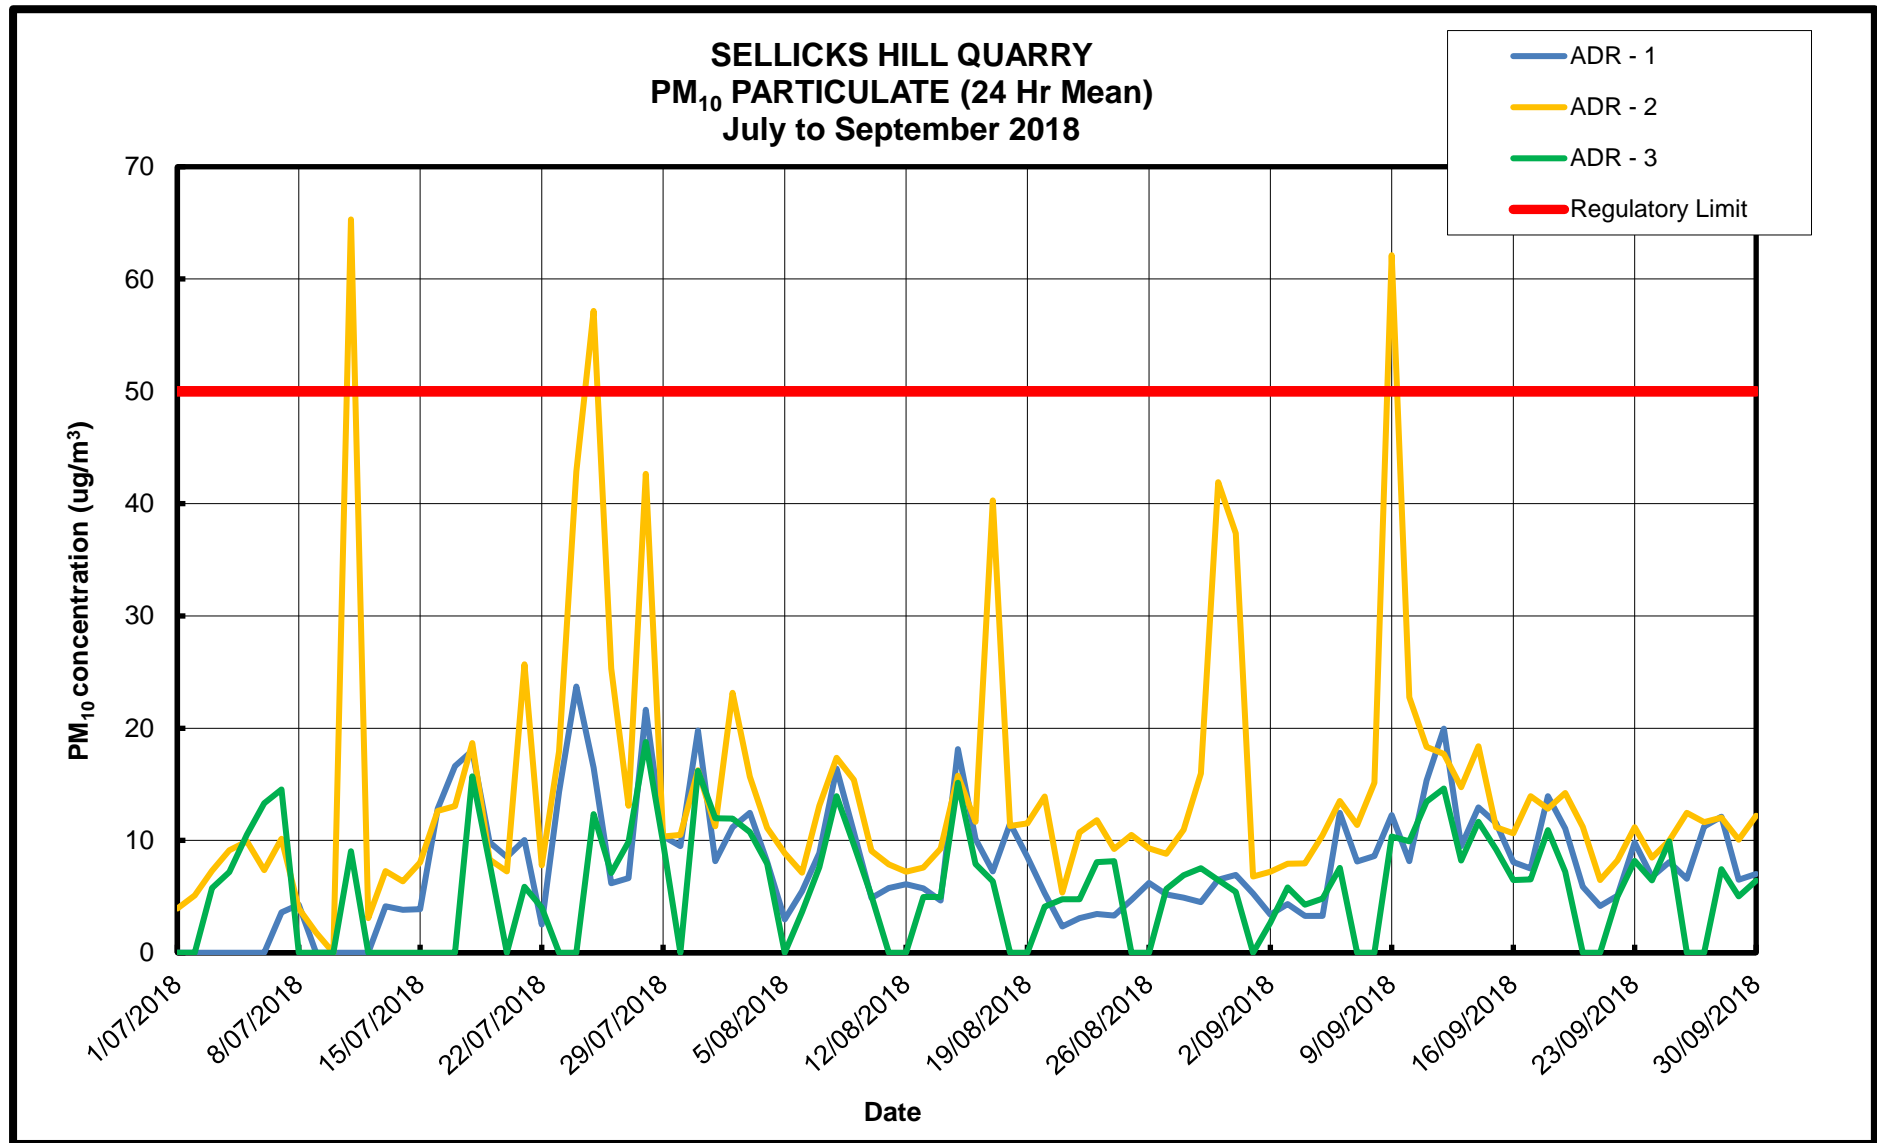
Appendix A – 24 hr Daily Average PM₁₀

ADR unit data showing the 24hr daily mean for the reporting period is attached (see Appendix A – 24hr Daily Average PM₁₀). There were three recorded exceedances above the regulatory limit of 50 µg /m³ per 24-hour period (mid-night to mid-night) at ADR2 during the quarter. These exceedances were due to low cloud and precipitation, with water droplets recorded as PM₁₀ fragments in the air stream. This is common at ADR2 during the winter months.
